### Inspection Report

Subject: Woodford County

2625 County Road 600N El Paso, IL 61738 Longview Swine Farm, LLC

May 27, 2011

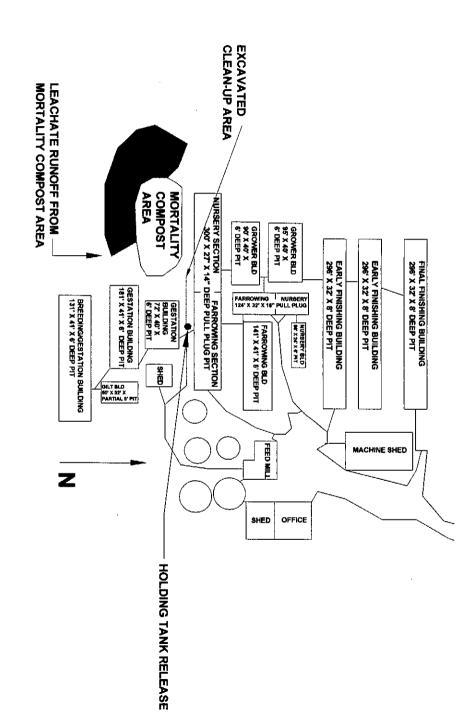
Figure 3. Plan View of Longview Swine Farm, LLC with building locations.

with estimated dimensions. Please see Figure 2 through Figure 4 for locations on site. This facility has 13 total confinement buildings on site. Below is a summary of the buildings
